**SHEPHERD**  
**HOME REPORT**

8 ABINGER GARDENS  
EDINBURGH  
EH12 6DE

# Energy Performance Certificate (EPC)

# Scottish Single Survey

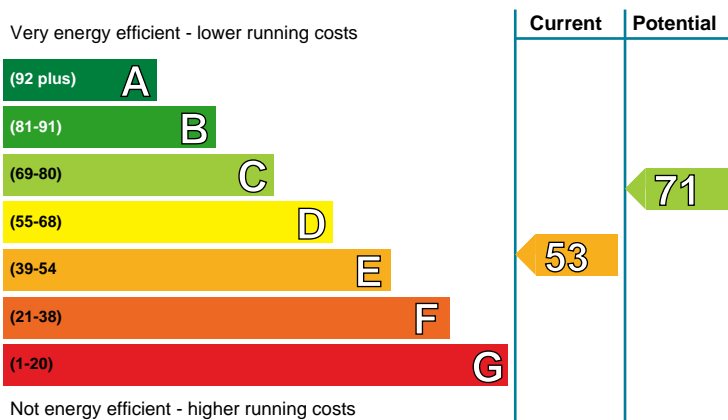
## Energy Efficiency Rating

This graph shows the current efficiency of your home, taking into account both energy efficiency and fuel costs. The higher this rating, the lower your fuel bills are likely to be.

Your current rating is **band E (53)**. The average rating for EPCs in Scotland is **band D (61)**.

The potential rating shows the effect of undertaking all of the improvement measures listed within your recommendations report.

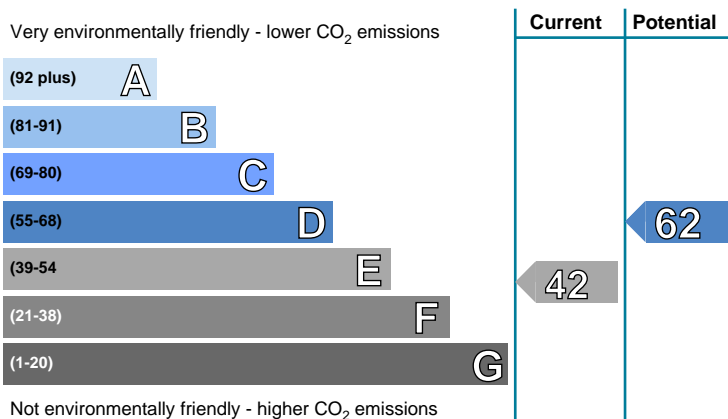
## Environmental Impact (CO<sub>2</sub>) Rating

This graph shows the effect of your home on the environment in terms of carbon dioxide (CO<sub>2</sub>) emissions. The higher the rating, the less impact it has on the environment.

Your current rating is **band E (42)**. The average rating for EPCs in Scotland is **band D (59)**.

The potential rating shows the effect of undertaking all of the improvement measures listed within your recommendations report.
